WEEKLY STATUS REPORT

BCP Project No.:	C224099	EPA Consent Order No.:	CERCLA-02-2017-2021	Date:	11/01/2019
Project Name:	BRT Powerhouse 153 2 nd Street AKA 322 3 rd Avenue, Brooklyn, NY 11215				
Remediation Activities (Week of October 28, 2019): <ul style="list-style-type: none">Continued gauging and product recovery via absorbent sock as necessary.					
Redevelopment Activities (Week of October 28, 2019): <ul style="list-style-type: none">Maspeth Welding (Site steel contractor) continued steel repair work in the turbine hall.Domani and Garden State Surveying, Engineering, and Planning (Site survey contractors) continued site surveying work as necessary.Structure Tech (Site foundation contractor) completed necessary maintenance of the groundwater treatment system. Structure Tech added additional absorbents to the influent tank, removed and drummed saturated absorbents, and replaced the bag filters and cartridges of the filtration components.Structure Tech continued offsite disposal of soil from the turbine hall load test stockpile. Structure Tech loaded forty-eight (48) trucks with approximately 1446 cubic yards of soil. Soil was disposed of to Blue Water Environmental, located at

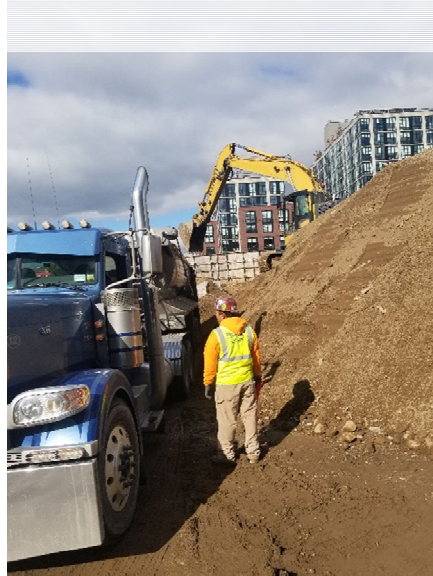
Photo 1 – Looking southwest in the west yard. Structure Tech loads trucks with soil from the turbine hall load test stockpile for transport to Blue Water Environmental.

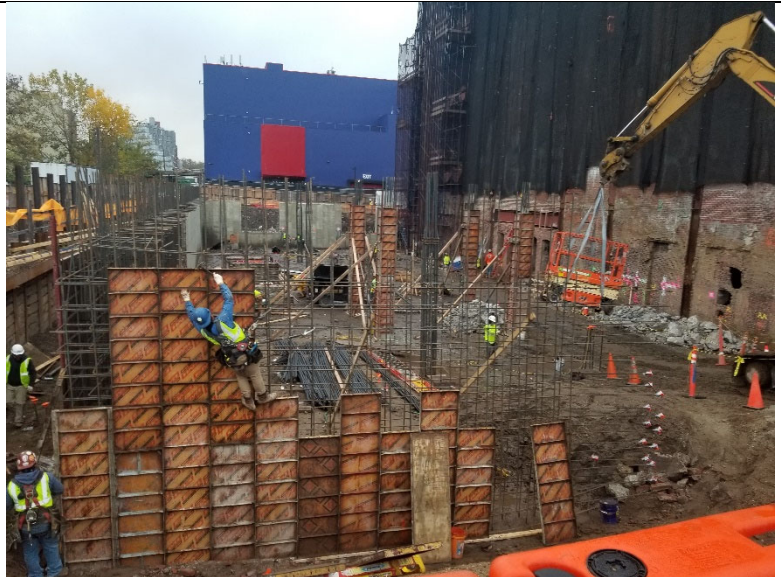
Photo 2 – Looking southeast at the boiler house slab. Formwork for boiler house wall being constructed.

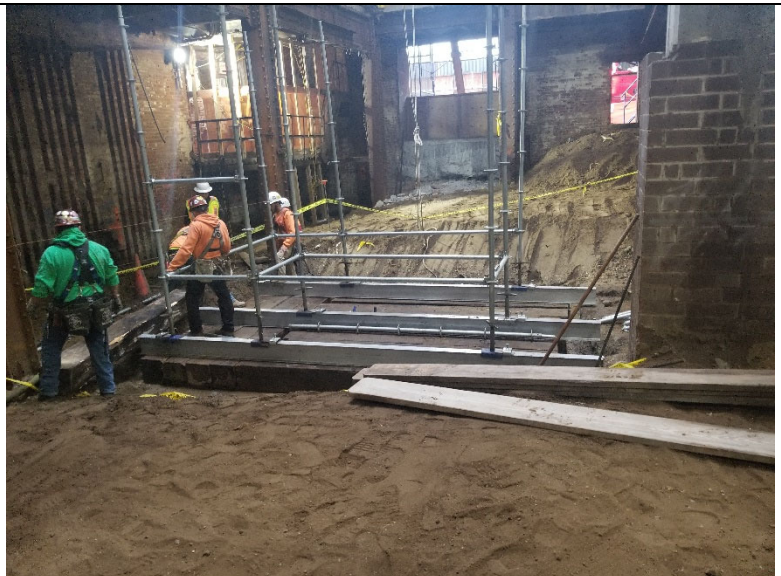
Photo 3 – Looking south in the turbine hall cellar. Start of the scaffold stair build within the turbine hall.
